ISTA 2A - Test Report

Report No.: NTC-SR2112009
Applicant's name.....: Shenzhen Goldenlux Co., Ltd
Address.....: 3/F Building 1, Bei Fang Yong Fa Industrial Area, Sha Jing
g Town, Bao'an District, Shenzhen, China

Drop test report	
Report Reference No.....:	NTC-SR2112009
Date of issue.....:	Dec. 8, 2021
Total number of pages.....:	8 Pages
Testing Laboratory:	Dongguan New Testing Centre Co., Ltd.
Address.....:	3F, No. 1 the 1st North Industry Road, Songshan Lake Science & Technology Park, Dongguan, Guangdong, China, 523808.
Tested by (name + signature).....:	Jack Zhang
Approved by (+ signature).....:	Neil Zhong
Applicant's name .. .:	Shenzhen Goldenlux Co., Ltd
Address .. .:	3/F Building 1, Bei Fang Yong Fa Industrial Area, Sha Jing Town, Bao'an District, Shenzhen, China
Manufacturer's name.....:	Shenzhen Goldenlux Co., Ltd
Address .. .:	3/F Building 1, Bei Fang Yong Fa Industrial Area, Sha Jing Town, Bao'an District, Shenzhen, China
Standard..... :	ISTA 2A: 2011
Test specification:	
Procedure deviation..... :	N/A
Non-standard test method..... :	N/A
Test item description :	LED High Bay
Model/Type reference..... :	GL-UFO200-K

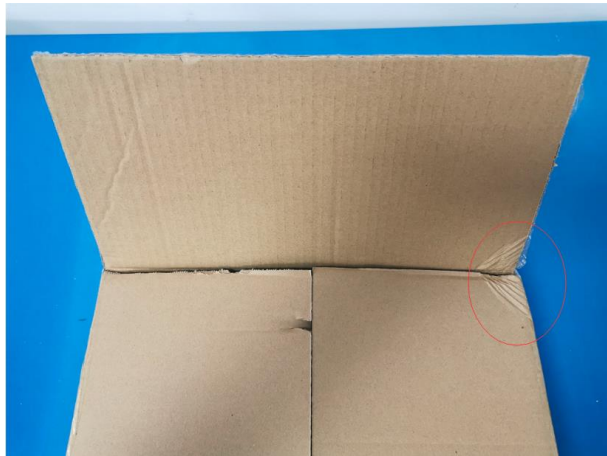
Post Test Comments	Overview:	There are crushed corners and edges for the outer corrugated carton of the sample. The front of the product is intact without breakage.
	Product Condition	The product is intact and undamaged.
	Packaging Condition	There are crushed corners and edges for the outer corrugated carton of the sample. There no breakages for the inner white protective foam.

Crushed corner and edge

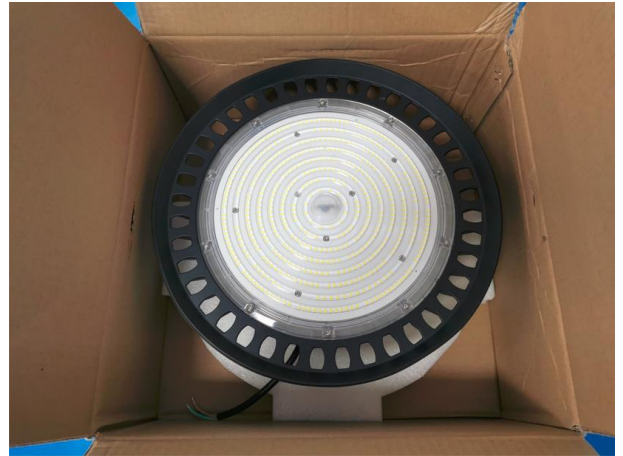
Product internal photo

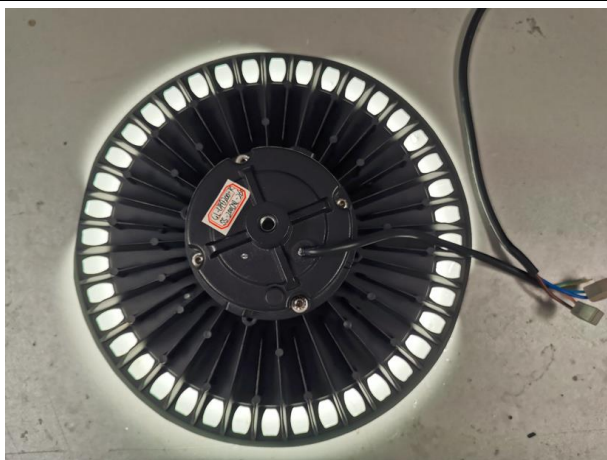
Photo of the product lit up after the test
