ISTA 2A - Test Report

Report No.: NTC-SR2112009
Applicant's name.....: Shenzhen Goldenlux Co., Ltd
Address.....: 3/F Building 1, Bei Fang Yong Fa Industrial Area, Sha Jing
g Town, Bao'an District, Shenzhen, China

Drop test report	
Report Reference No.....:	NTC-SR2112009
Date of issue.....:	Dec. 8, 2021
Total number of pages.....:	8 Pages
Testing Laboratory:	Dongguan New Testing Centre Co., Ltd.
Address.....:	3F, No. 1 the 1st North Industry Road, Songshan Lake Science & Technology Park, Dongguan, Guangdong, China, 523808.
Tested by (name + signature).....:	Jack Zhang
Approved by (+ signature).....:	Neil Zhong
Applicant's name .. .:	Shenzhen Goldenlux Co., Ltd
Address .. .:	3/F Building 1, Bei Fang Yong Fa Industrial Area, Sha Jing Town, Bao'an District, Shenzhen, China
Manufacturer's name.....:	Shenzhen Goldenlux Co., Ltd
Address .. .:	3/F Building 1, Bei Fang Yong Fa Industrial Area, Sha Jing Town, Bao'an District, Shenzhen, China
Standard..... :	ISTA 2A: 2011
Test specification:	
Procedure deviation..... :	N/A
Non-standard test method..... :	N/A
Test item description :	LED High Bay
Model/Type reference..... :	GL-UFO200-K

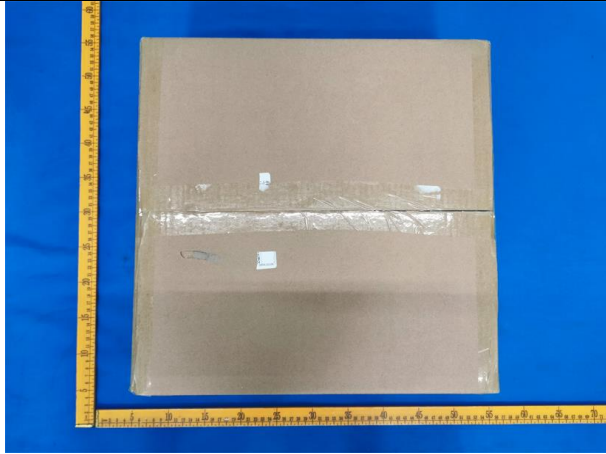
Side 1

PRE-TEST INSPECTION {filled out by lab}	
Product Condition	No damage (checked by client).
Package Condition	No appearance or structure damage on the outer carton.
Package Condition before testing	ORIGINAL as arrived in the lab for testing

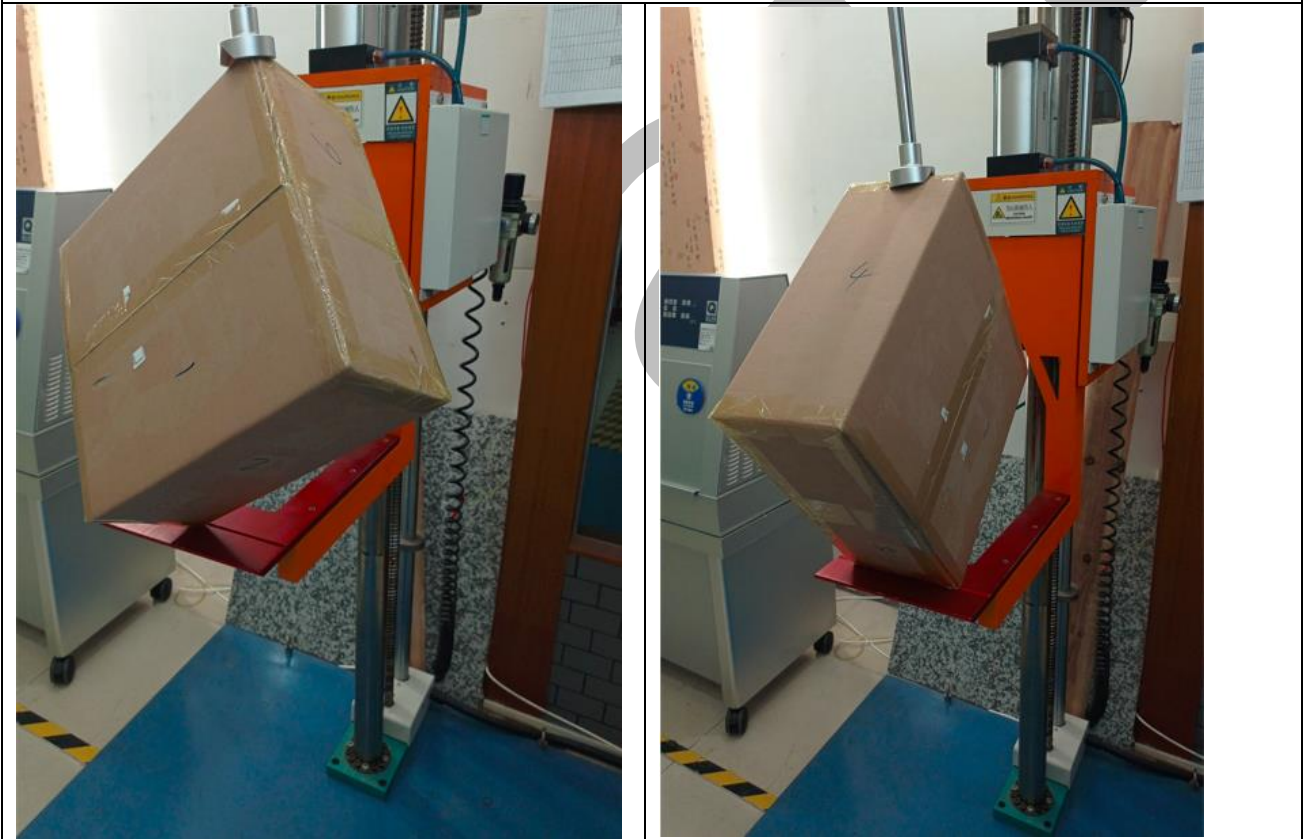
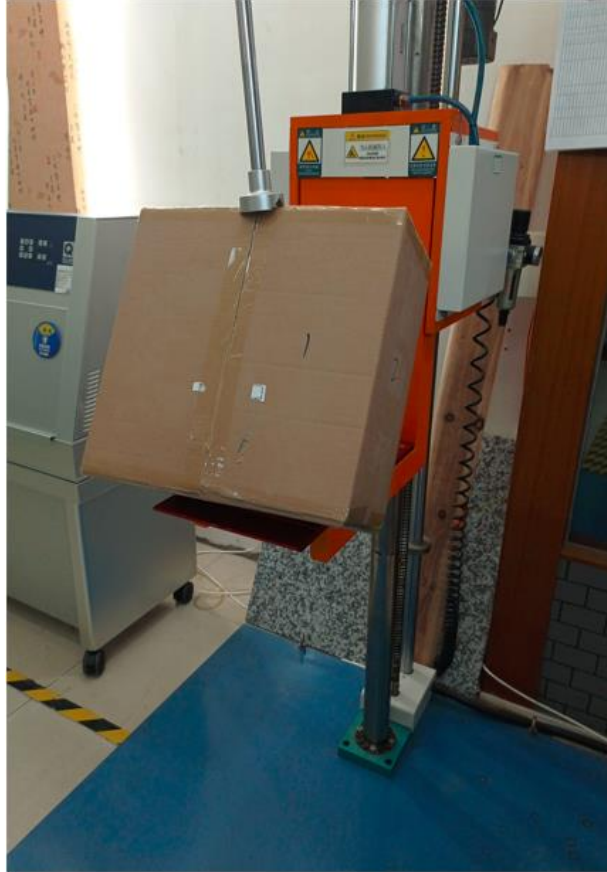
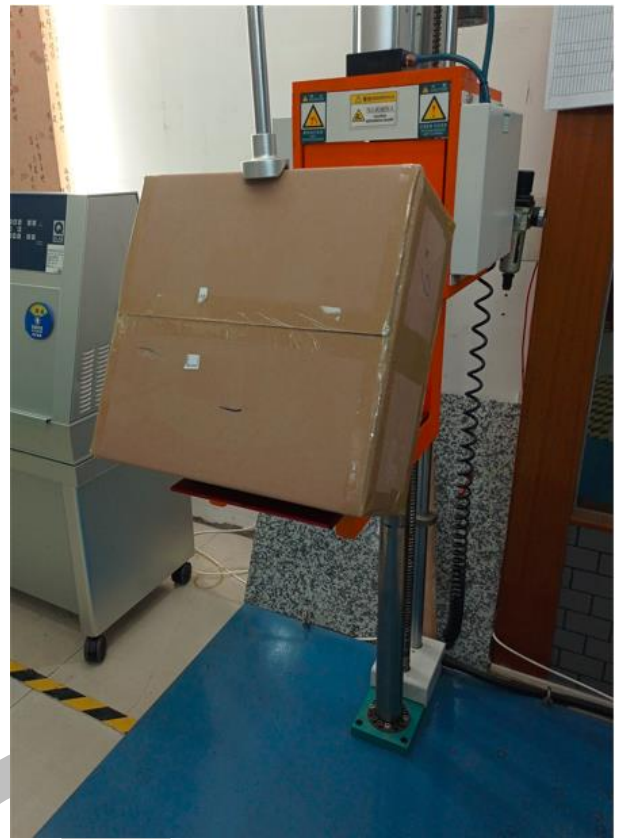
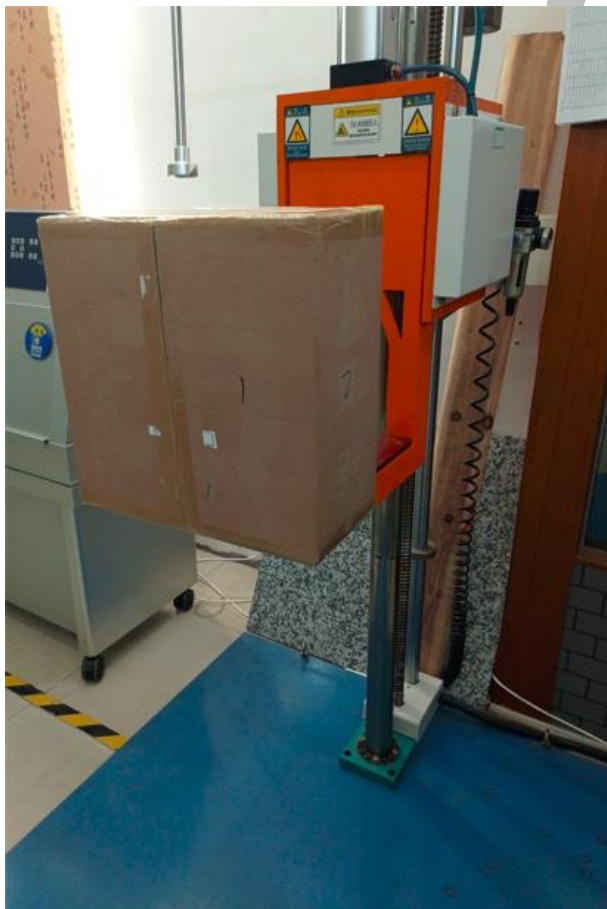
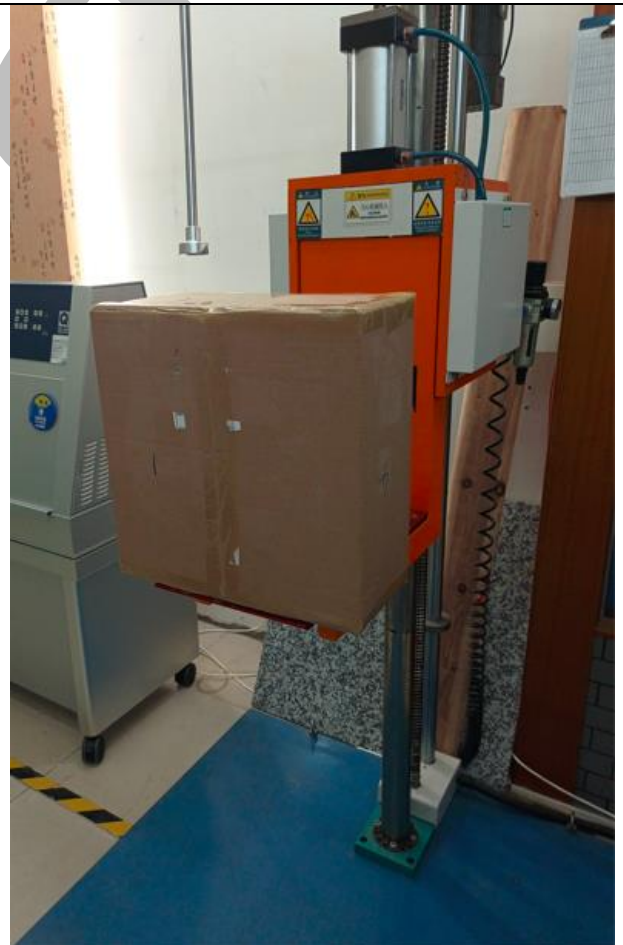
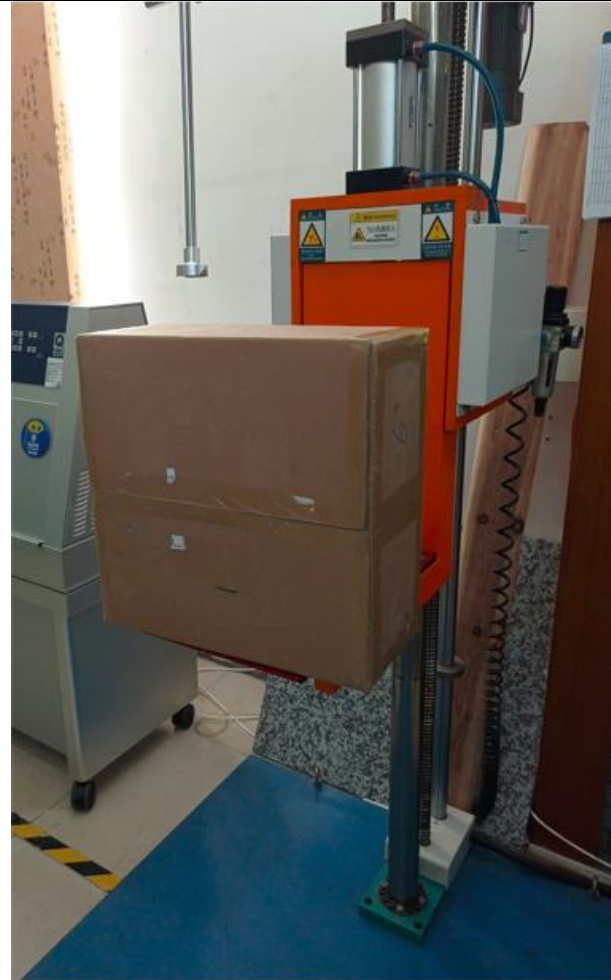
Test	Value	P/F	OBSERVATIONS
BLOCK 1:Temp and Humidity	20.6°C, 49%RH	P	Ambient Lab Temp 12+ hours
BLOCK 2: Drop 1-7	970mm	P	Slight crushed corners for outer carton
BLOCK 2: Drop 8	970mm	P	No obvious appearance damage.
BLOCK 2: Drop 9	970mm	P	No obvious appearance damage.

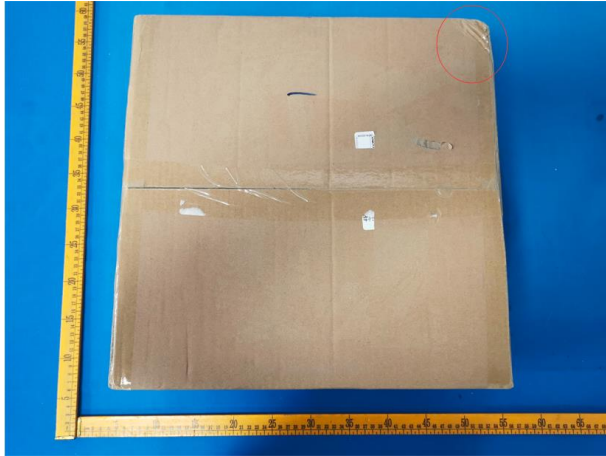
ISO #1 Side 1

Post Test Comments	Overview:	There are crushed corners and edges for the outer corrugated carton of the sample. The front of the product is intact without breakage.
	Product Condition	The product is intact and undamaged.
	Packaging Condition	There are crushed corners and edges for the outer corrugated carton of the sample. There no breakages for the inner white protective foam.
